Underground Leak Detection Survey Using Infrared and  
Ultrasound Technologies Saves Time and Repair Costs

By Drew Walts, SME and Training Manager at IRISS, Inc.

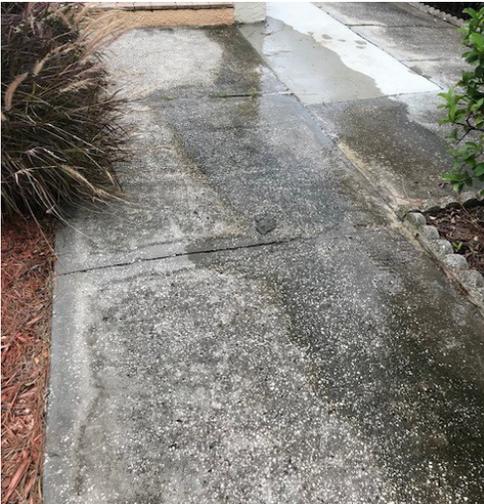
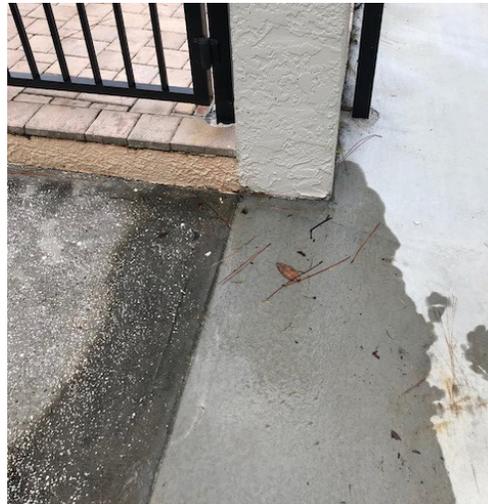
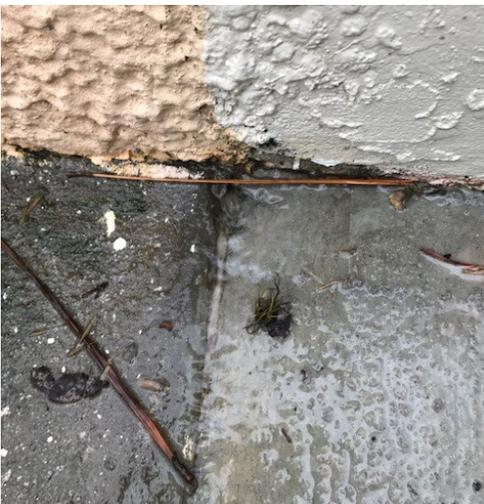
Chad then contacted Drew Walts of IRISS Inc. and asked if IRISS had any technology that could look at the area and locate the leak. The best approach was to observe the area in the evening when the solar heating ended so the concrete temperature would be cooler. Upon arrival, Drew saw a noticeable stream of water in the street coming from the base of the pool's patio area. There was a noticeable bubbling from a seam where the pad met the sidewalk. Drew's hypothesis for visiting in the evening was to first use an Infrared Camera to locate the target area and then zoom in on the location using an ultrasound device to locate the leak. .

Figure 2 – Water Seepage Observed at the Site

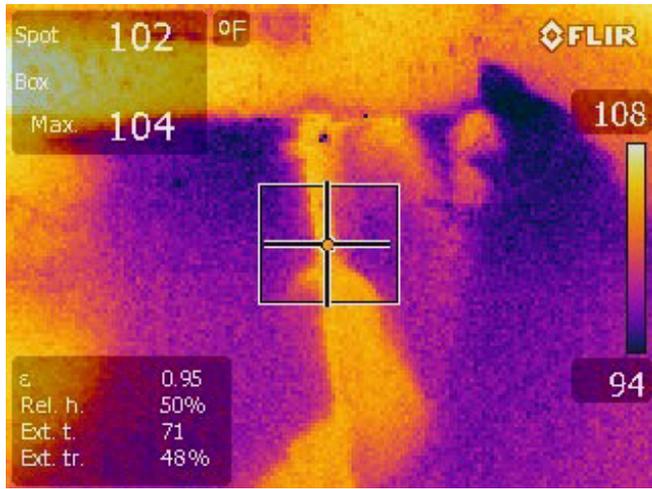
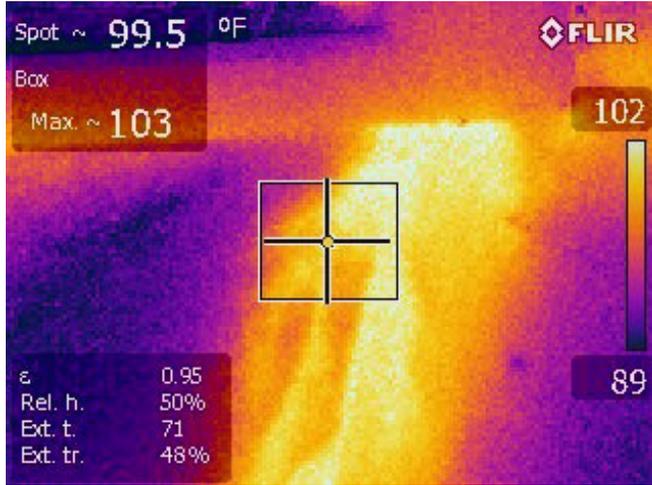
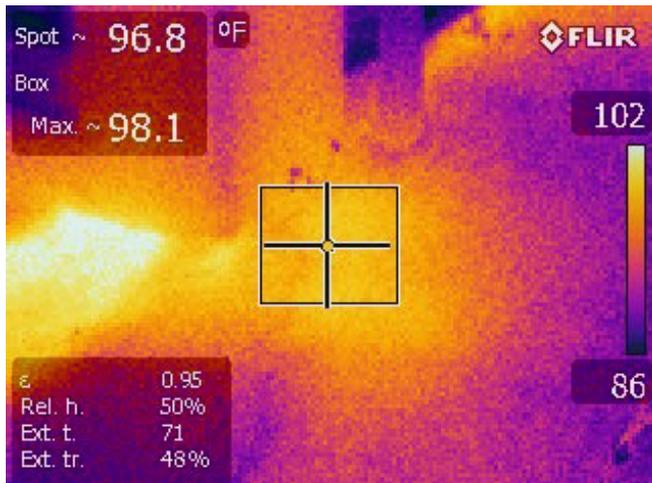
Using the IR Camera, the area around the south east corner was the coolest area and the moisture in the sidewalk was cooling further out than the visible stream of water. Recently, a new section of concrete sidewalk had been poured around this corner. After scanning the entire pool area, the only noticeable area of concern was at the pool entrance area where the stream of water was originating. The area where the first visible signs of a leak were coming from was visually warmer than the surrounding area. This just happened to be in the same area where the newest concrete had been poured. The general location of the leak had been found.

Figure 3 – Infrared Images of the Sidewalk and Pool Deck

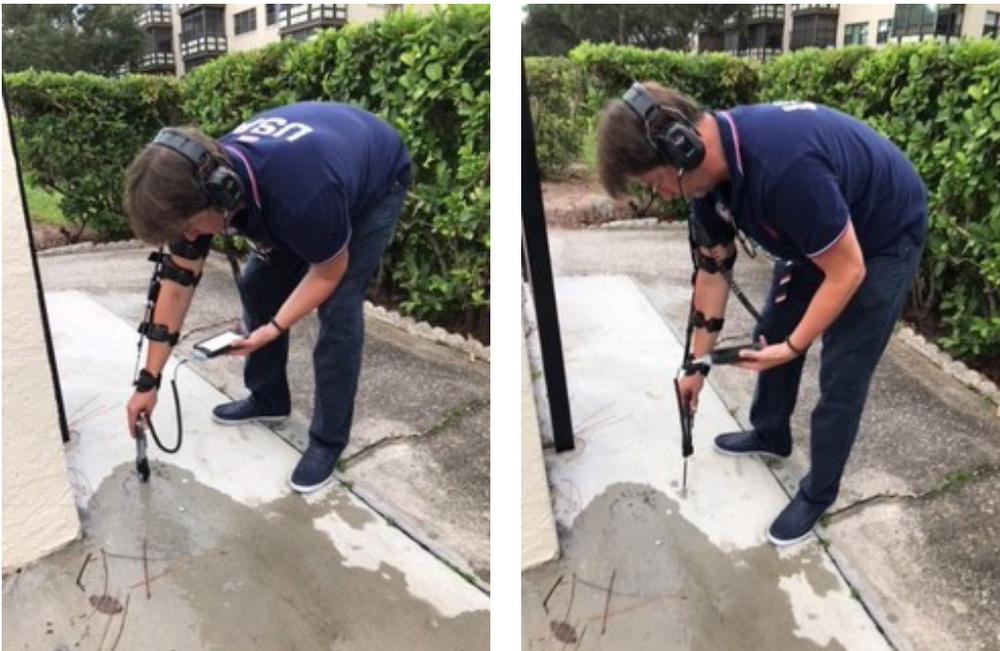
Next, two holes were drilled at the base of the pad and the sidewalk. No noticeable sounds were observed; however, the dirt that came up with the drill was moist. Another hole was drilled to the right and the dirt was also moist and, a small amount of water started trickling from this new hole. When the Sonaphone III rod was placed into the hole, a slight decibel indication of 1-3 decibels was present as well as a small noise that sounded like little baby bird tweeting. Another hole was made at the base of the pillar and the new sidewalk where the dirt was moist, and, within a few seconds, a very noticeable flow of water started to appear. The flow of water through this new hole caused the water flowing from the other two locations to slow down. The Sonaphone III rod was inserted into this latest hole and the decibels immediately jumped up to 15-18 decibels and a distinct sound of bubbling was heard. The exact location of the leak had been found.

Figure 4 – Using the Sonaphone Ultrasound Tester to Pinpoint the Leak

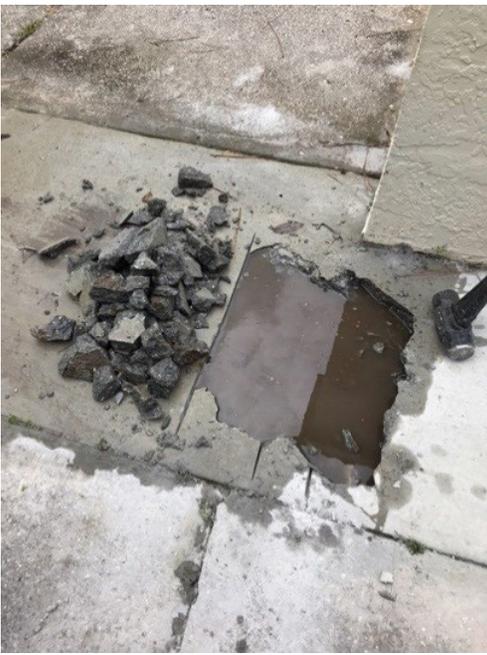
Upon removing the new concrete, brown muddy water immediately started flowing. When Chad felt inside the pool of water, he found a split in a PVC irrigation line.

Figure 5 – Brown Muddy Water Quickly Filled the Concrete Excavation

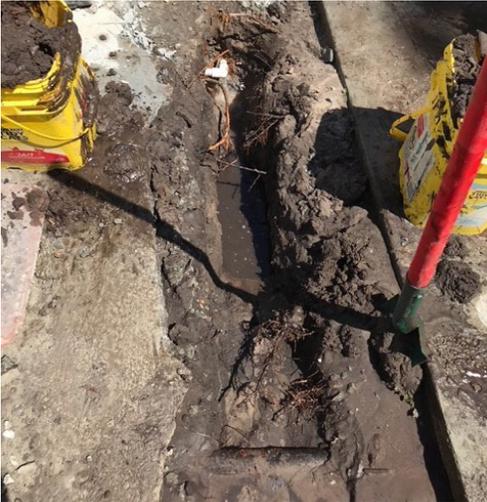
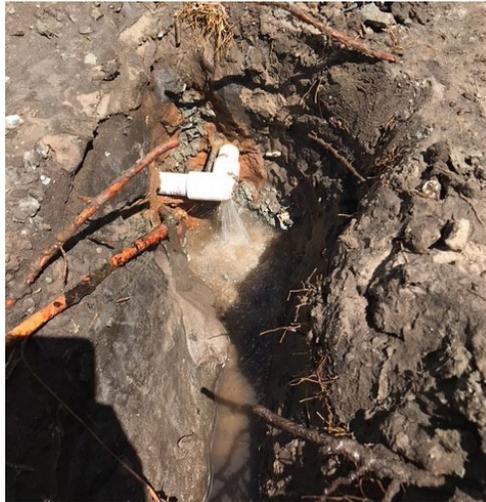
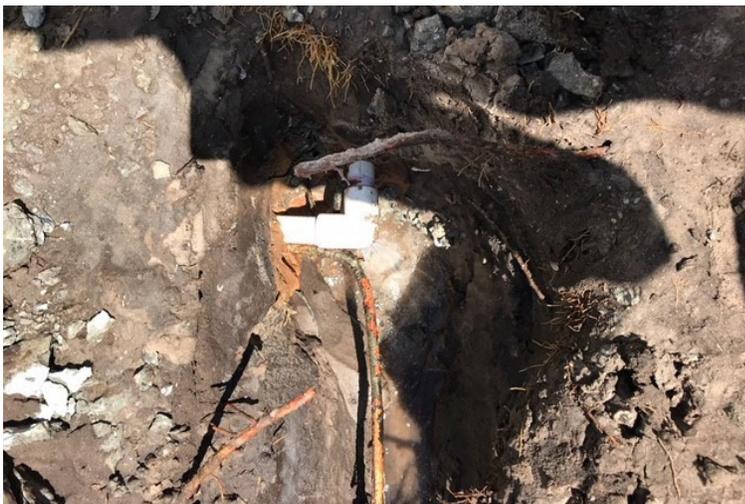
The photos below were taken during the full excavation and extraction of the water. The leak originated from the bottom of the PVC elbow. This leak could have been a result of over-pressurization, water hammer, defective pipe or human error during installation of the new concrete pad.

Figure 6 – Burst PVC Irrigation Pipe Elbow
