Underground Leak Detection Survey Using Infrared and  
Ultrasound Technologies Saves Time and Repair Costs

By Drew Walts, SME and Training Manager at IRISS, Inc.

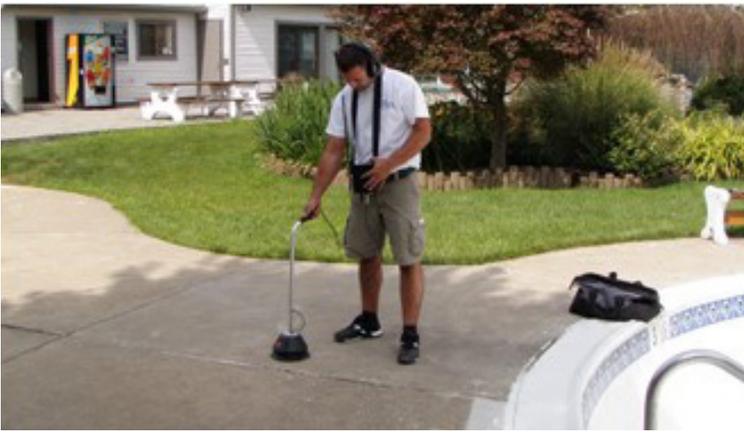
Figure 1 – Specialized Water Leak Detector 300-5000Hz in Use

Chad then contacted Drew Walts of IRISS Inc. and asked if IRISS had any technology that could look at the area and locate the leak. The best approach was to observe the area in the evening when the solar heating ended so the concrete temperature would be cooler. Upon arrival, Drew saw a noticeable stream of water in the street coming from the base of the pool's patio area. There was a noticeable bubbling from a seam where the pad met the sidewalk. Drew's hypothesis for visiting in the evening was to first use an Infrared Camera to locate the target area and then zoom in on the location using an ultrasound device to locate the leak. .
